The Vulcan returns

Getting Avro Vulcan XH558 airborne after a period of 15 years represented one of the aerospace industry's most challenging restoration projects to date. **RICHARD WARRILOW** reports.

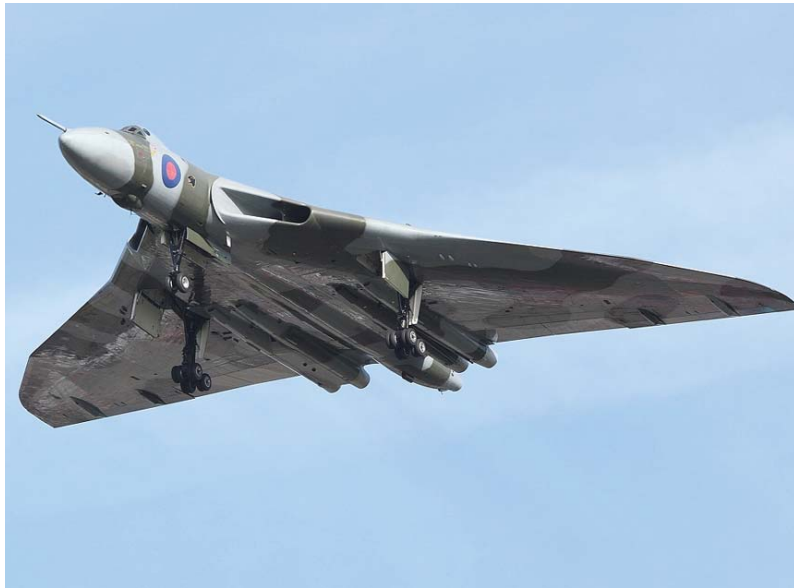
The world's only airworthy Vulcan, XH558. Main photo left: XH558 begins its first post-restoration flight on 18 October 2007.

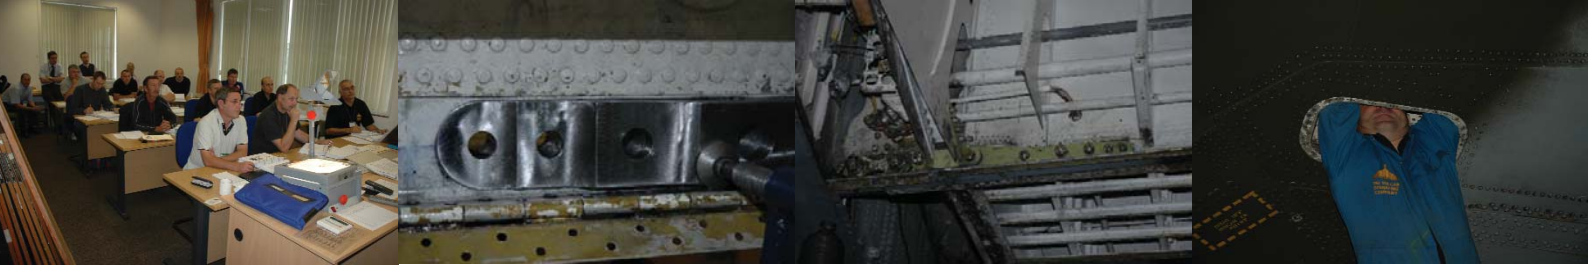
Left: Back to school: Technicians from TVOC and Marshall Aerospace spend an intensive two months learning about the Mark II Vulcan, using revamped training material (based on material which would have been written in 1950s). Second and third left: Mod' 2222 ("four twos") was part of the major service due in 1993. This mod' sees the fitting of four elongated steel plates, one of which is shown above (left), to supplement the original (and much shorter) two-hole, figure of 8 shackle joints used to secure the wings to the fuselage. On the right, we see finished mod'. Right: Work on the XH558 frequently required working in confined spaces. Above, a technician squeezes his way into the leading edge of the Vulcan's wing — inside which he will work.

One task which drew on several of these resources was the strengthening of the wing spars under 'Modification 2222'. Done to extend fatigue life, this mod' (dubbed "four twos") would have been part of the service due in 1993 and required the fitting of four steel plates; used in pairs to sandwich and strengthen the joints where the bottom of the rear wing spar attaches to the centre section of the aircraft. Rogers: "Although the basic design had been developed by BAE Systems, planning had to be created and tooling and parts manufactured, plus, during the work, specialist aircraft trestles were required to

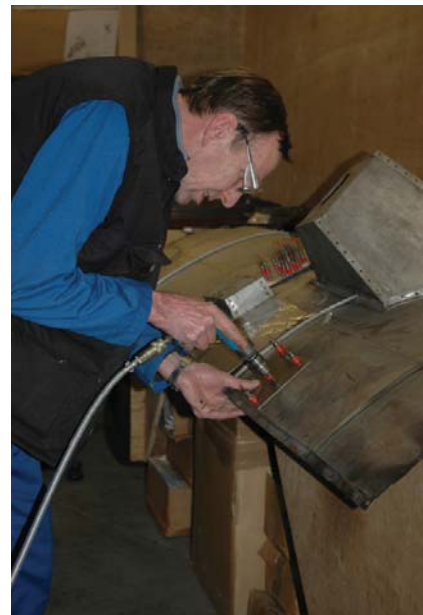
The discovery of significant corrosion in the [wing] undercarriage bays warranted the removal of the top skins for further investigation and access to several stringers for repair.

But perhaps the largest drain on resources was dealing with unexpected corrosion. The detailed survey had confirmed that, in general, the airframe was in excellent condition — a testimony to the way it was originally designed and built. However, some significant corrosion was found in the wing above the undercarriage bays. Boyle comments: "And this needed the removal of the top skins for further investigation. The picture was far worse than expected, and many stringers were in a very poor state."

While some stringers could be surface-treated many required the removal of sections and the splicing in of new material. However, the technicians were restricted by the limitations of a Structural Repair Manual (SRM) on not only how many repairs could be made to any one stringer but also how many repairs could be present on adjacent stringers. In order to avoid programme delays, a night shift was introduced to get the work completed.
